DARTER AND BARENBERG CONSULTING ENGINEERS URBANA IL
BONDED CONCRETE OVERLAYS: CONSTRUCTION AND PERFORMANCE. (U)

BONDED CONCRETE OVERLAYS: CONSTRUCTION AND PERFORMANCE

September 1980

Final Report

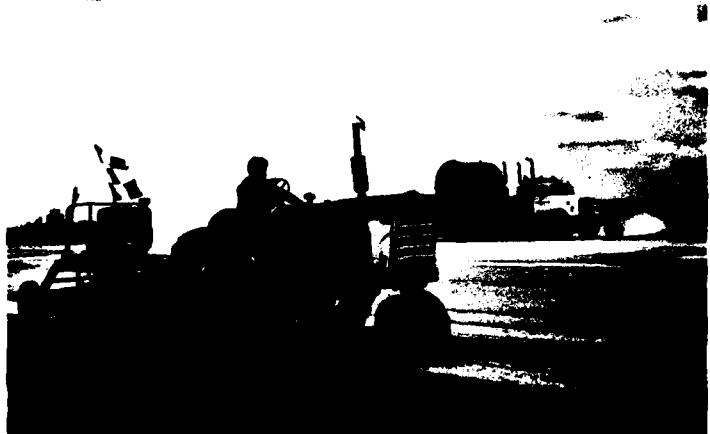
Figure 2.9. Brooming of Roto-Milled Surface (Foreground) and Water Blast Cleaning of Surface (in Background) at Willard Airport.

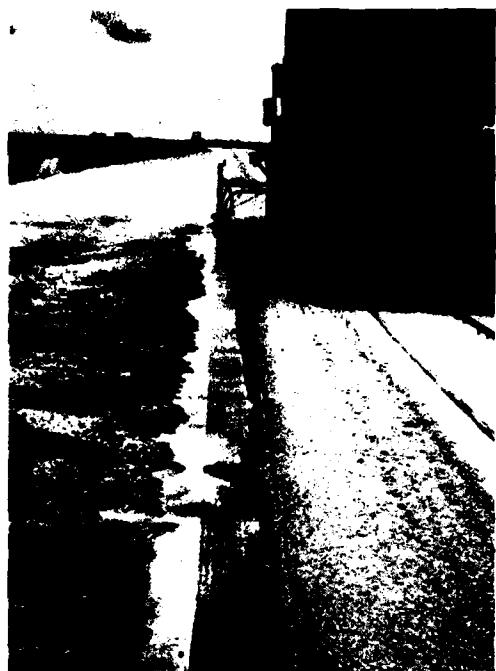
Figure 2.10. Water Blast Cleaning of Roto-Milled Surface at Willard Airport.

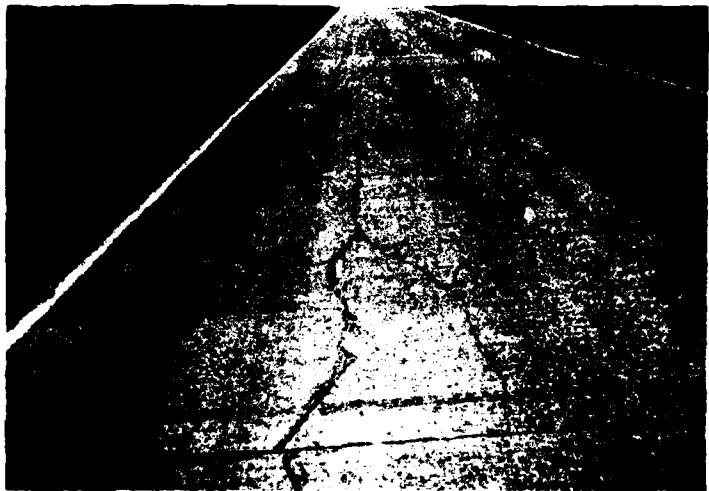
Figure 3.6. Photo of Reflection Cracking in Concrete Overlay for Slab Shown in Figure 3.5, 1979.

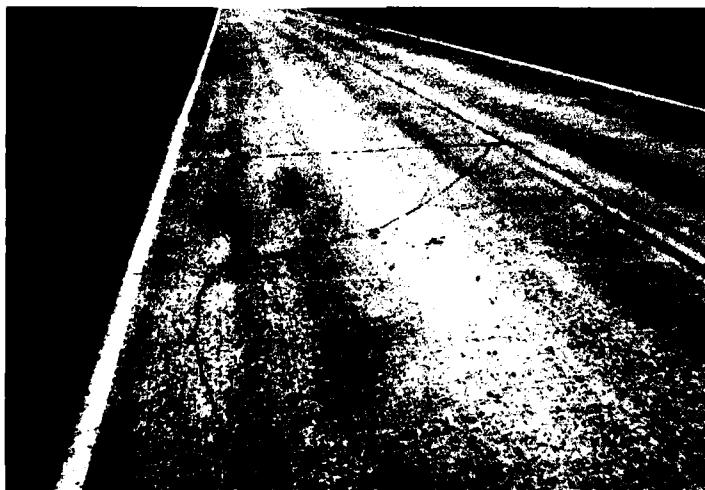
Figure 3.8. Photo of Reflective Cracking in Concrete Overlay for Slab Shown in Figure 3.7.

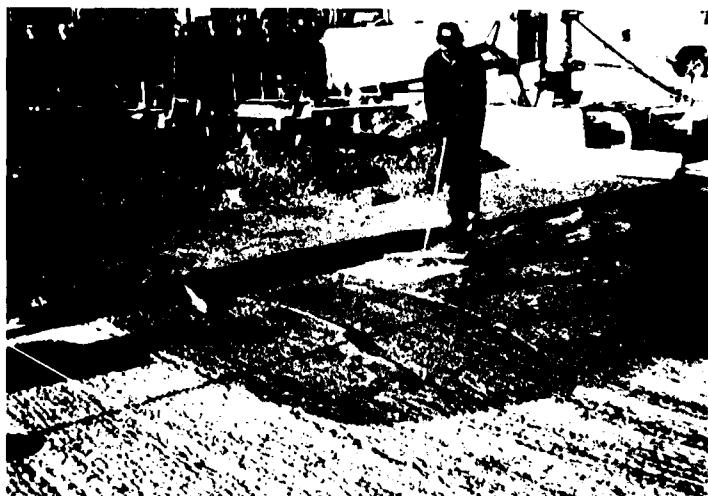
Figure 4.2. Spreading of Sand-Cement Grout on Roto-Milled Surface of Willard Airport, Champaign, Illinois, 1979.

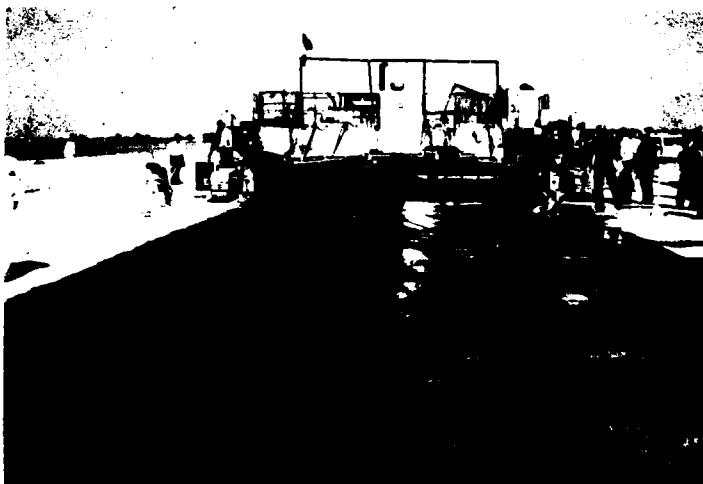
Figure 4.3. Photo Showing Milled and Grouted Fully Bonded Slab on Left, and Non-Milled and Non-Grouted Partially Bonded Area on Right at Willard Airport, Illinois, 1979.

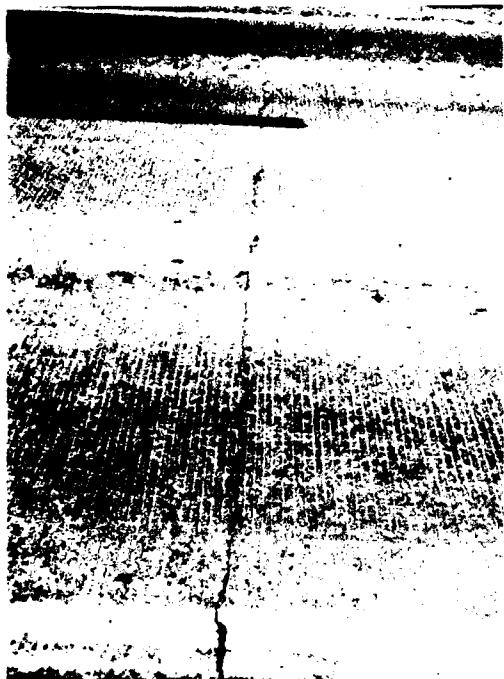
Figure 7.3. Reflection Crack from a Transverse Joint in the Base Slab, a Typical Non-Sawed Joint at Clayton Co., Iowa, View 2.

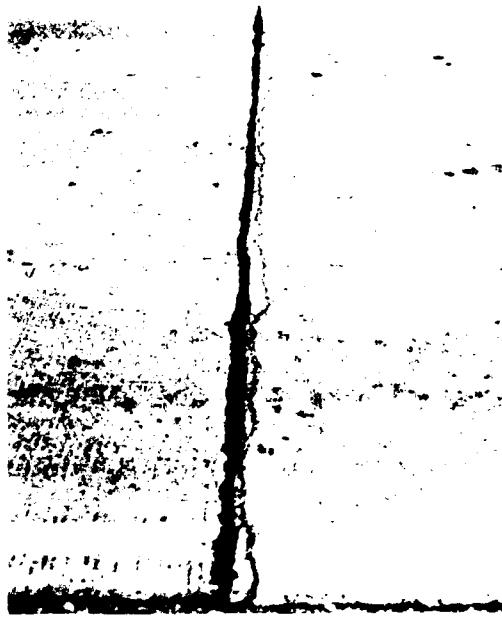
Sawed joints in bonded concrete overlays also present some problems. Figures 7.5 and 7.6 show a sawed joint with a secondary crack adjacent to the saw cut. This type of distress appeared in over 25 percent of the sawed contraction joints in the thin overlays in the Clayton County project (2), but was found to be less severe in the thicker overlays. At Willard Airport, where the bonded overlay was nearly 8 inches in thickness, only 11 joints out of several hundred in the project exhibited the secondary joint

Figure 7.5. Sawed Transverse Joint in Overlay that has Developed a Secondary Joint Crack (Clayton Co., Iowa), View 1.

To eliminate the secondary joint cracking problem, it will be necessary to form the weakened plane in the overlay at a much earlier age. If, as hypothesized above, the crack is initiated at an early age in the concrete, then it is probable that it will be necessary to form the joint while the concrete is still plastic. Even if an attempt is made to saw these joints at an earlier age, the crack would likely have already been initiated by the time the concrete is hard enough to permit sawing. Also, just getting

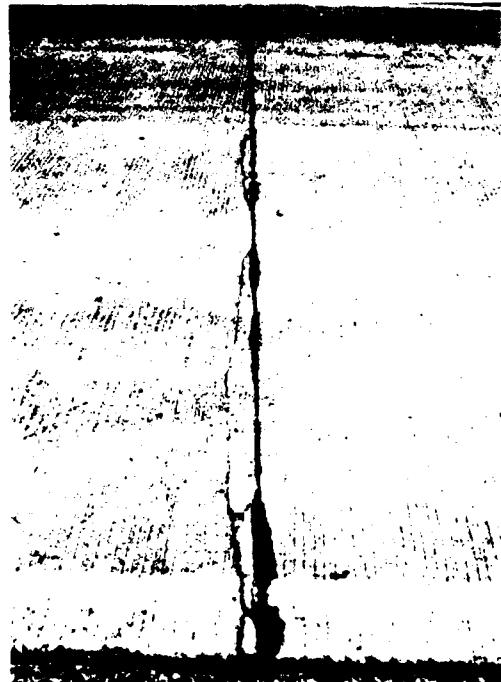
Figure 7.6. Sawed Transverse Joint in Overlay that has Developed a Secondary Joint Crack (Clayton Co., Iowa), View 2.

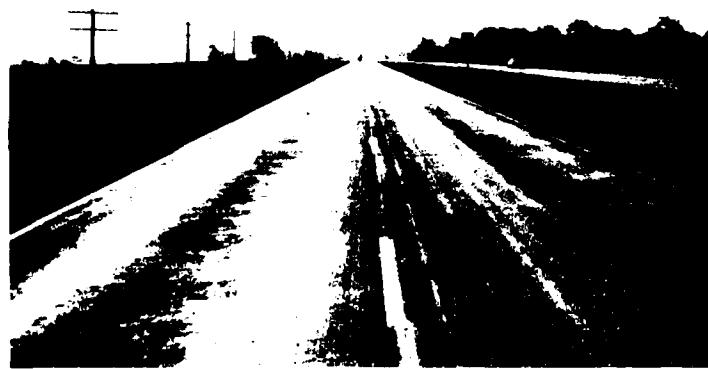
Figure 8.2. Overall View of Waterloo, Iowa Bonded Overlay, 1979.

patches, where two parallel cracks developed some reflective cracking especially along the centerline which was not sawed (Figure 8.2) and in one area where there is some minor shrinkage cracking of the concrete (Figure 8.3). As indicated in Section 3, the bond was checked with a Delametect approximately 6 months after construction and except for one small area there was no evidence of delamination of the pavement. Shear strengths measured on cores taken from the pavement averaged 956 psi with a standard deviation of 375 psi. The lowest shear value obtained was 210 psi. Cores were taken at 6 and 16 weeks with approximately the same results.

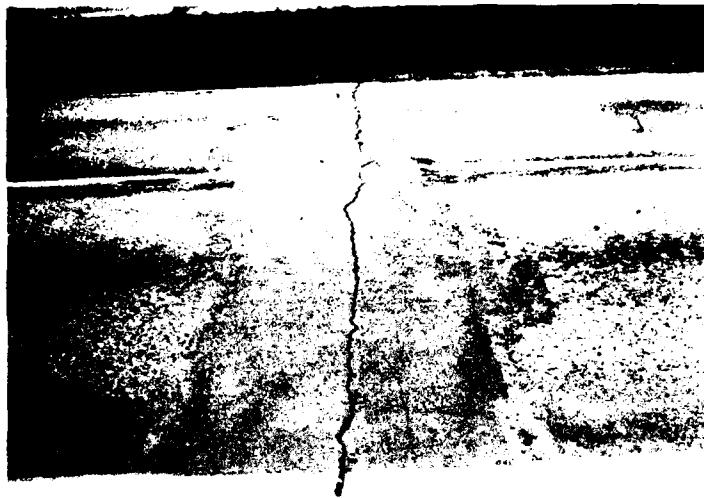
Figure 8.4a. Typical Crack Through a Partial-Depth Patch at Joint in Waterloo Project.

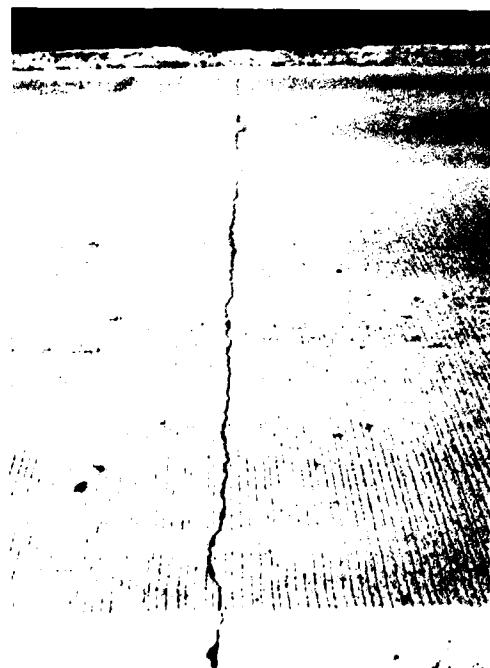
On the U.S. 20 project some joints were sawed partial-depth through the overlay and others were not sawed but allowed to reflect through the overlay. A typical example of each type is shown in Figures 8.5 a and b. Some spalling was observed in the non-sawed joints but this was not considered a severe problem.

Figure 8.5a. Typical Sawed Transverse Joint in the Waterloo, Iowa, Project.

Figure 8.5b. Typical Non-Sawed Reflected Joint in the Waterloo, Iowa, Project.

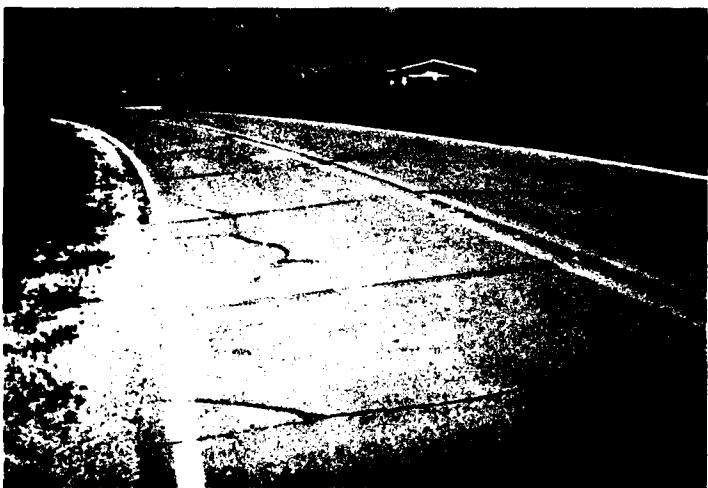
Figure 8.6. Original Base Slab at Clayton Co.,
Iowa, Showing Broken Up Area.

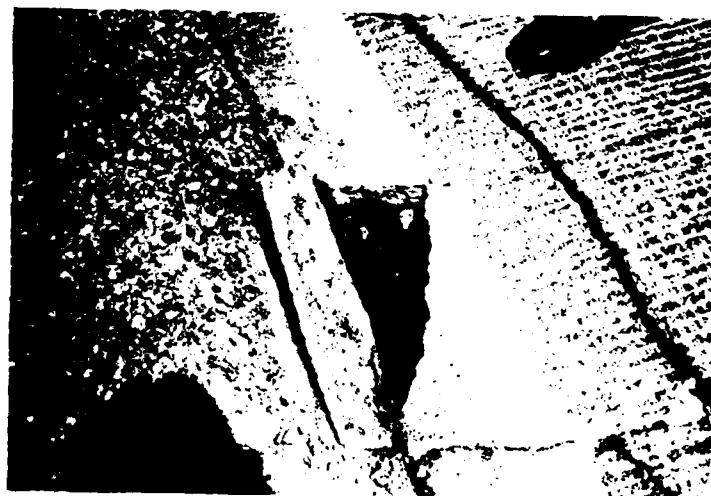
Figure 8.7b. Closeup of Figure 8.7a.

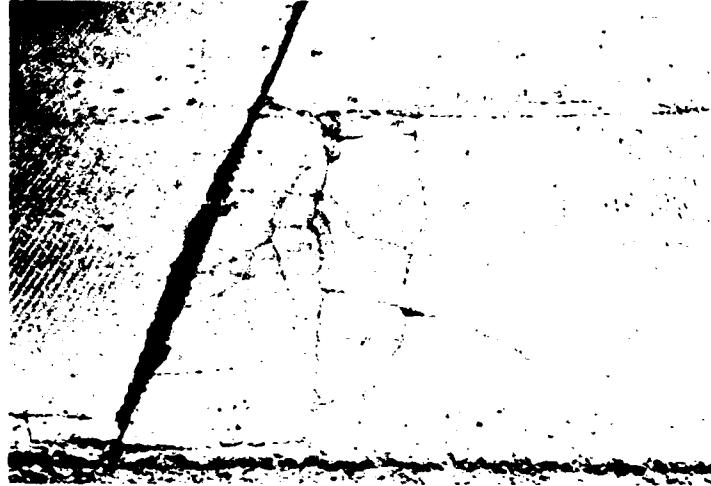
Figure 8.8. Localized Area of Debonding of 2-in. Overlay Where Water Blasting Was Used as Surface Preparation Method at Clayton Co., Iowa.

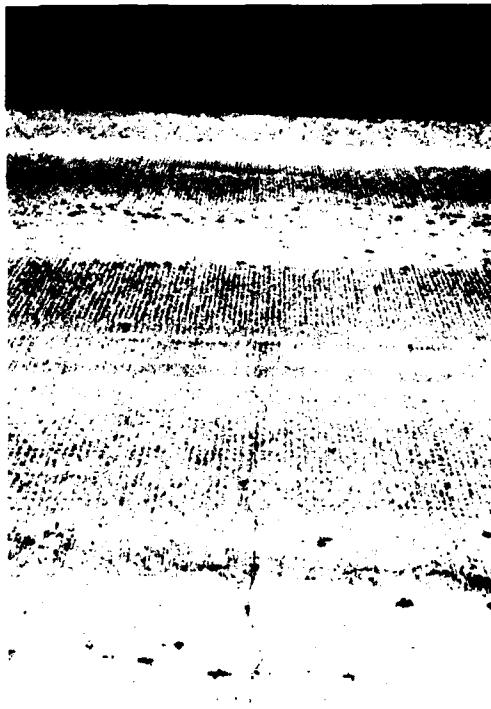
With all overlay thicknesses, most cracks in the original pavement have reflected through. There is some evidence that the time required for the crack to reflect through is extended somewhat with the thicker-overlays, but after approximately two years of service most cracks have reflected through. Typical reflected cracks for 2- and 5-inch-thick pavements are shown in Figures 8.10 and 8.12.

Figure 8.10. Reflective Crack in 2-in. Overlay with Sandblasting as Surface Preparation.

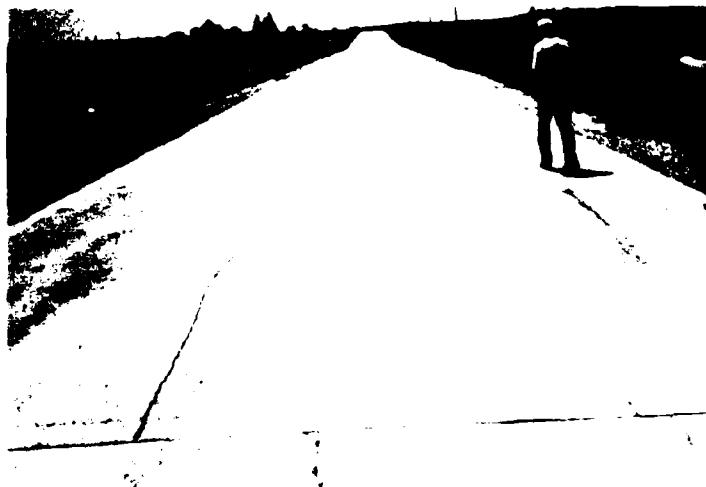
Figure 8.12. Reflective Cracking of 5-in. Overlay in Figure 8.11.

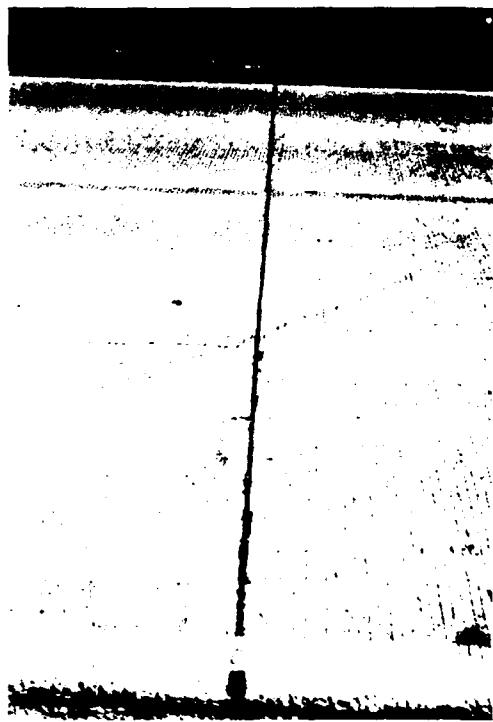
Figure 8.13. Sawed Transverse Joint
in 5-in. Overlay at
Clayton Co., Iowa.

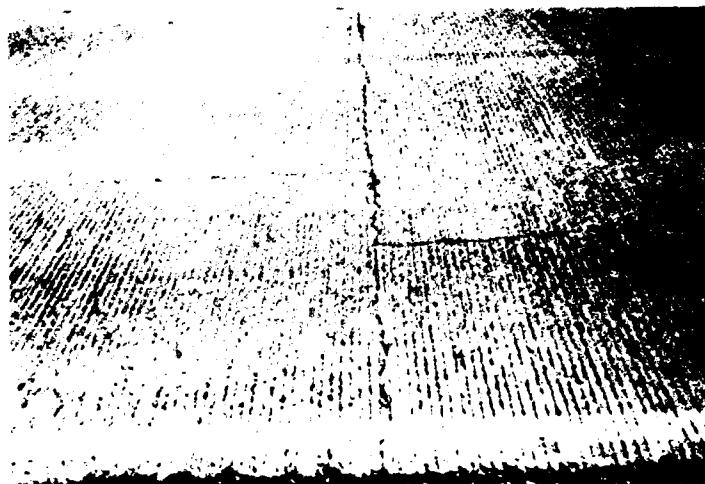
Figure 8.19. Reflective Cracking Through 4-in. Overlay for Slab Shown in Figure 8.17.

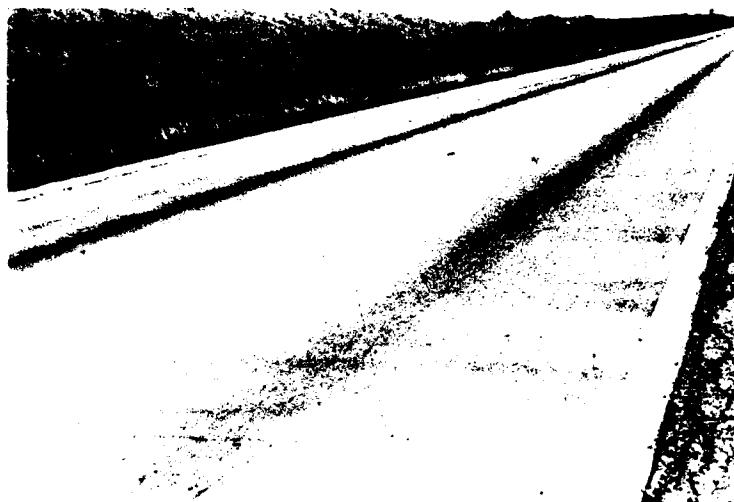
Figure B-1. General Condition of I-80 Shown in the Westbound Lane Which Was Not Being Overlaid at This Time.

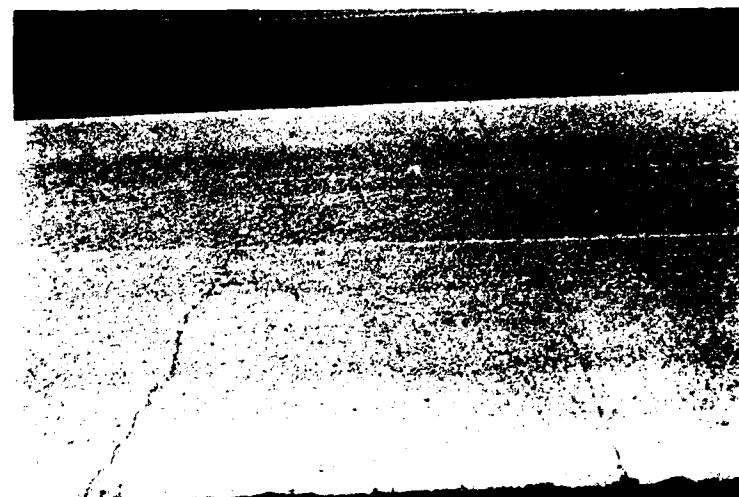
Figure B-4. Side View of Milled and Sandblasted Surface Showing a Transverse Joint and Crack.

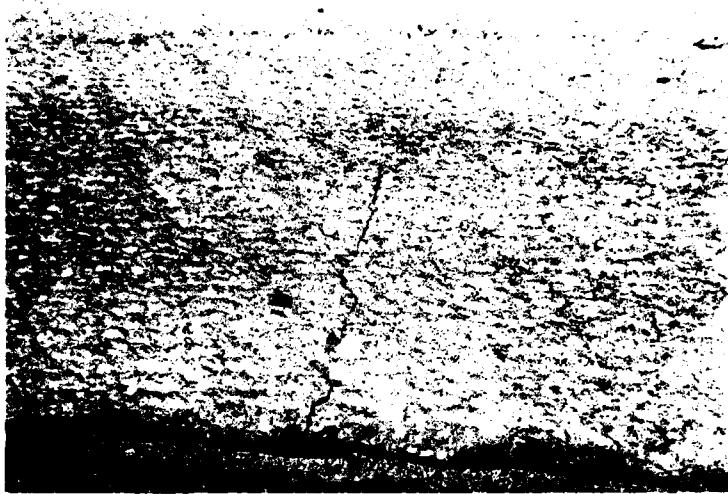
Figure B-5. Closeup of the Transverse Crack Showing the Final Surface Condition. Note the Absence of Spalling Along the Crack.

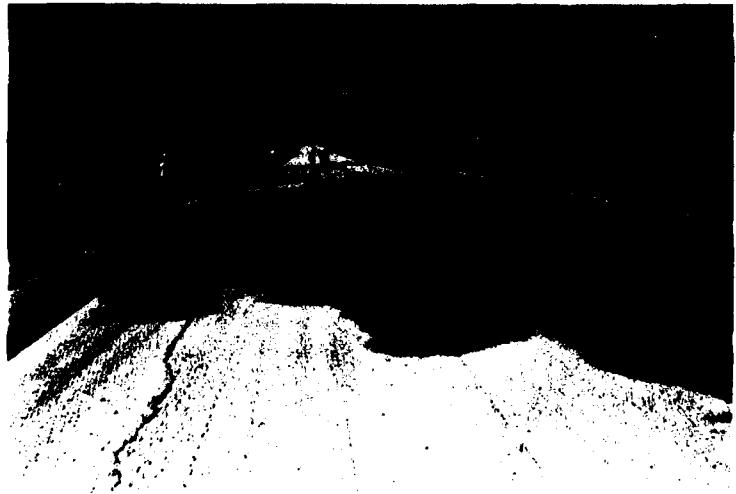
Figure B-10. Sand Cover Placed at Turnaround Locations on the Pavement to Prevent Rubber Buildup on the Prepared Surface.

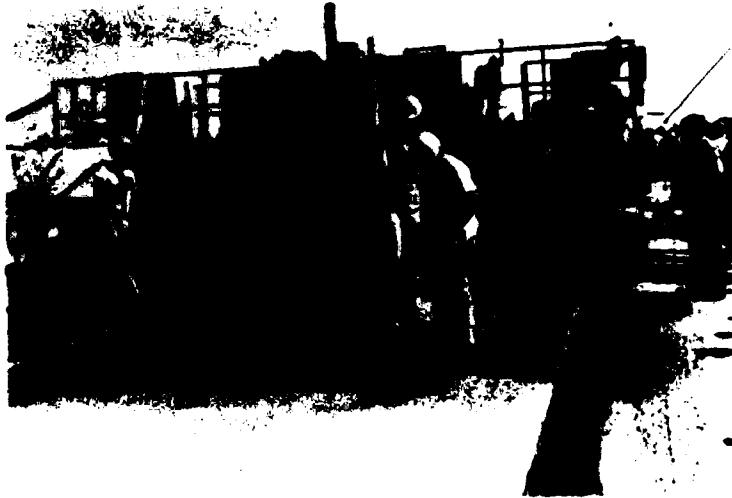
Application of the water-cement grout by pressure spraying just in front of the paver is shown in Figure B-11. Note in Figure B-12 how the truck backing over the grouted area has not picked up any of the grout on the tires, even though only a few minutes had lapsed between application of the grout and the arrival of the truck.

Figure B-11. Spraying of the Neat Cement Grout in Front of the Paver.

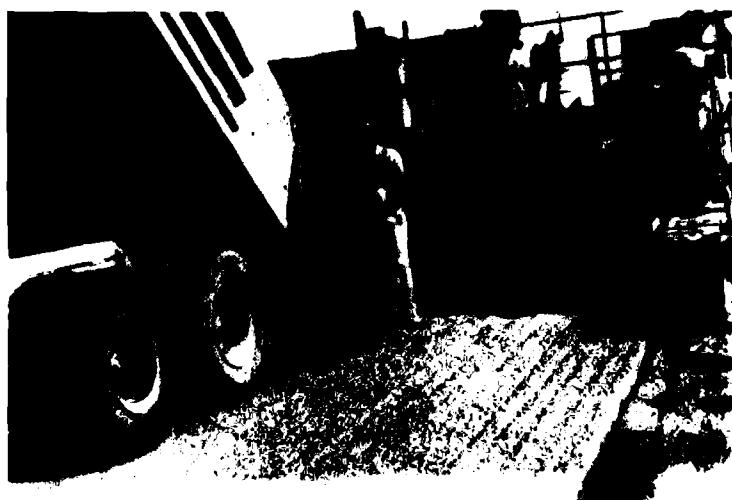
Figure B-12. Front View of Paver With Concrete Truck Rear Tires in Grouted Area. Note the Absence of Any Grout Pickup on the Rear Tires.

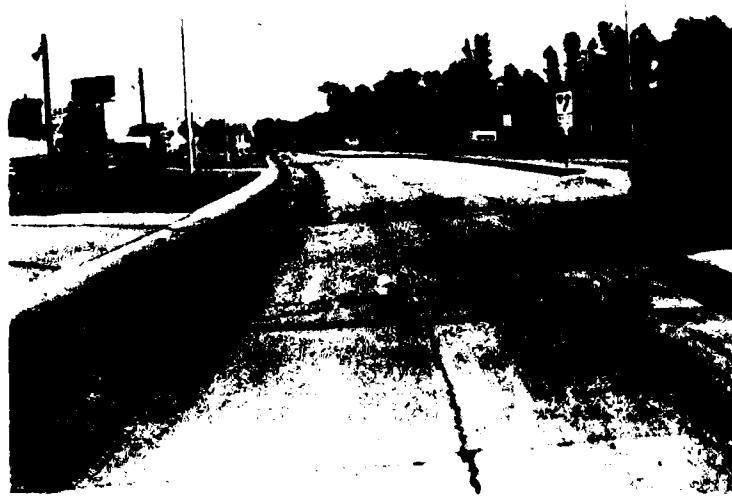
Figure B-16. Overview of Westbound Lanes of Bonded Concrete Overlay With Longitudinal Joint Between Old Existing Outer Slab and Widening Slab--Note Spalling of Reflected Non-Sawed Longitudinal Joint.
